Complete Streets Tier 2 Prioritization Plan: Town of Natick

June 2016

Windshield Survey Progress

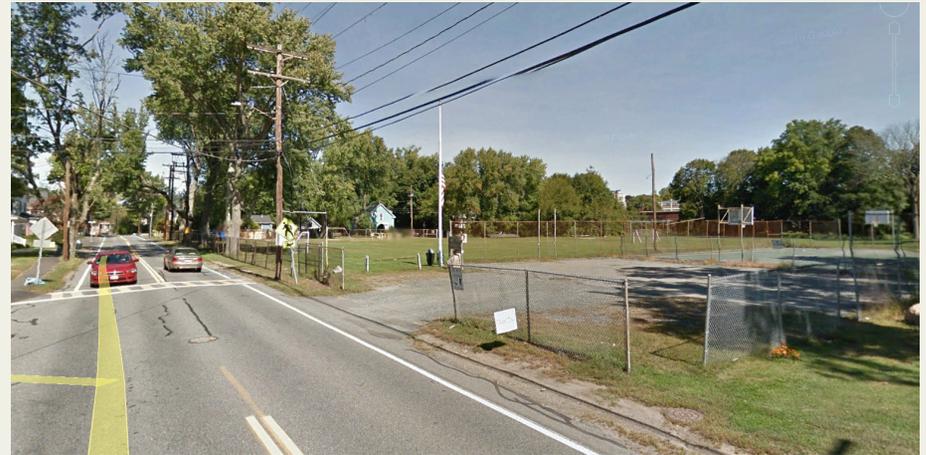
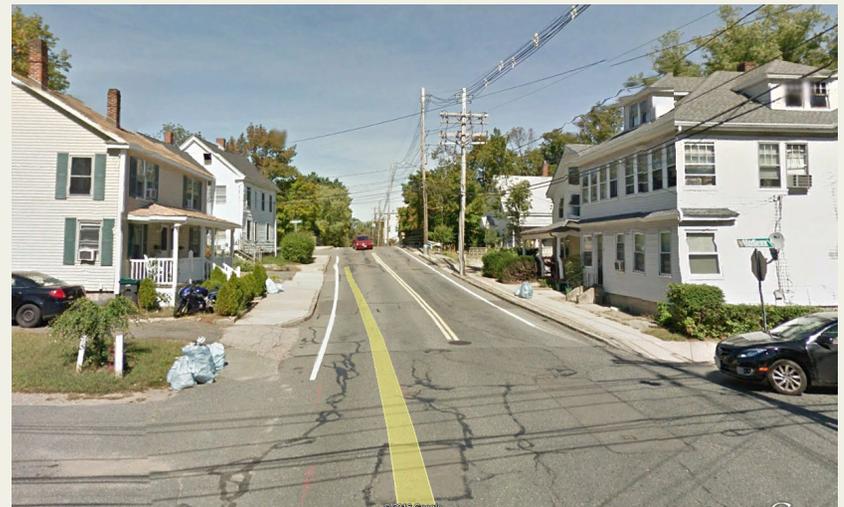
Washington Avenue*

- Roadway too narrow to accommodate bicyclists (only 9' lane/1.5' shoulder per direction)
- Gap in the sidewalk exists on the east side between Cochituate Street and Lagrange Street
- Trip hazards are present on the sidewalk
- Asphalt curb ramps are uneven and either steep or non-existent
- Few detectable warning panels

*Scheduled for repaving in 2017

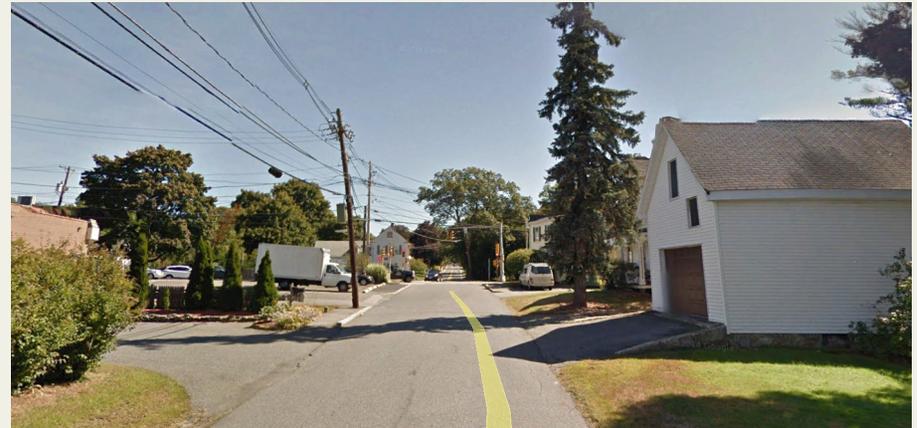
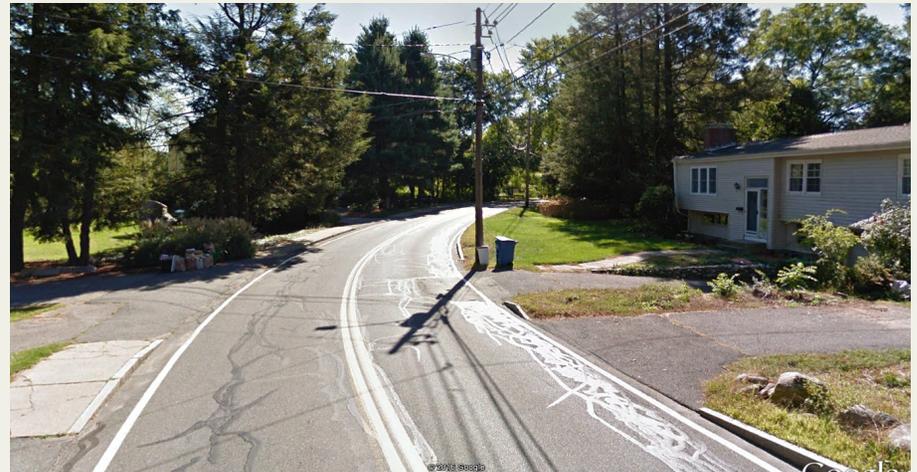
Bacon Street

- Gaps in sidewalk on south side, east of Route 27
- No bicycle accommodations
- No sidewalk west of Route 27

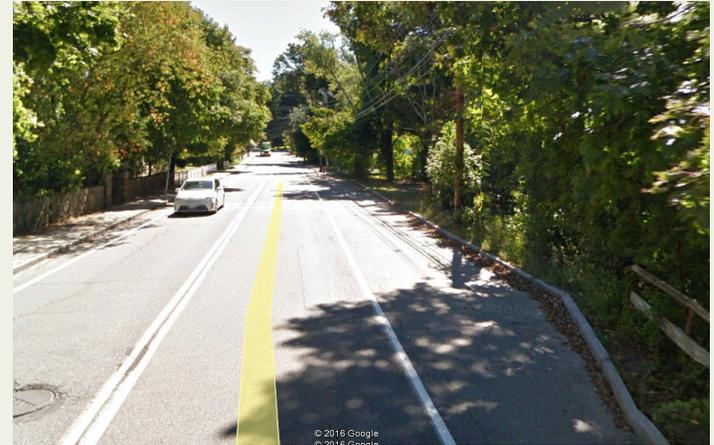
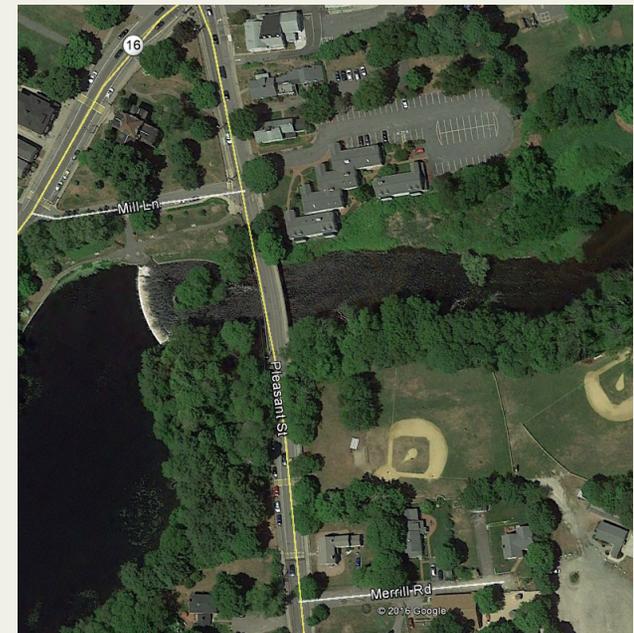
- Gaps exist in the sidewalk along Pleasant Street South
- Multiple midblock crosswalks are present without warning signage adjacent to Little League fields
- A bicycle crash has occurred in this area
- Limited or no bike parking

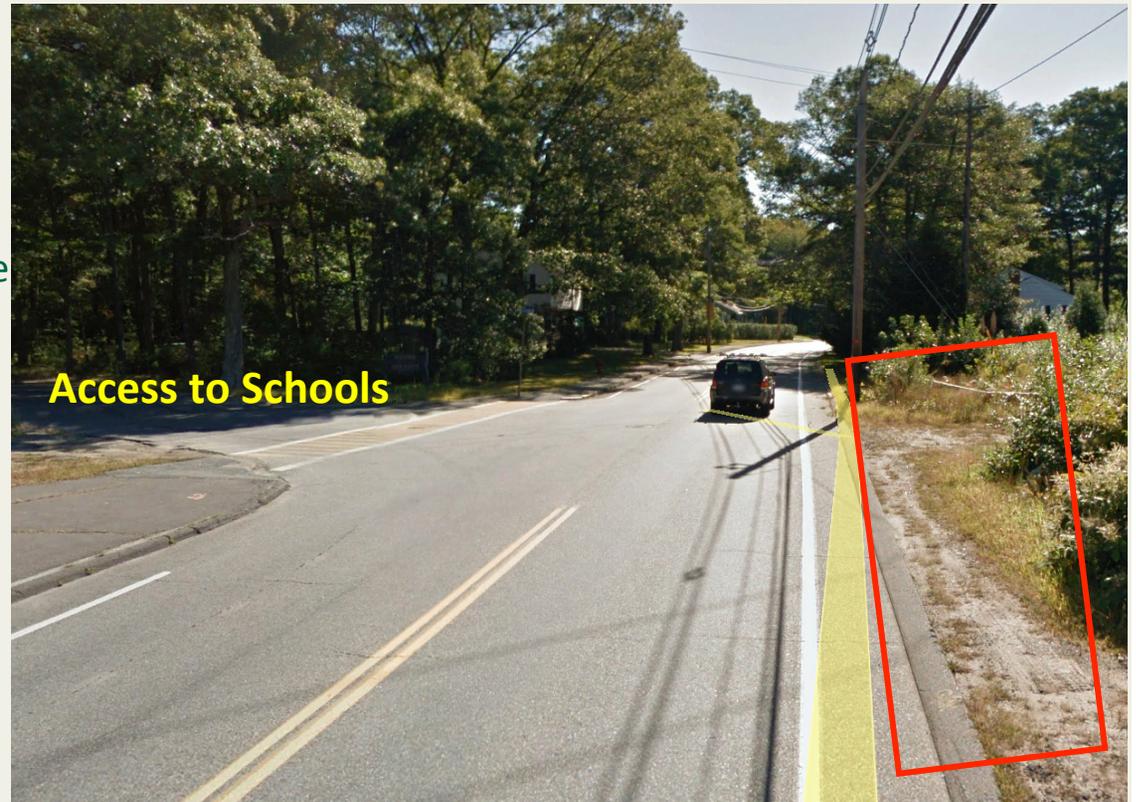
Looking south on Mill Street at school access

- There are gaps in the sidewalk along Mill Street

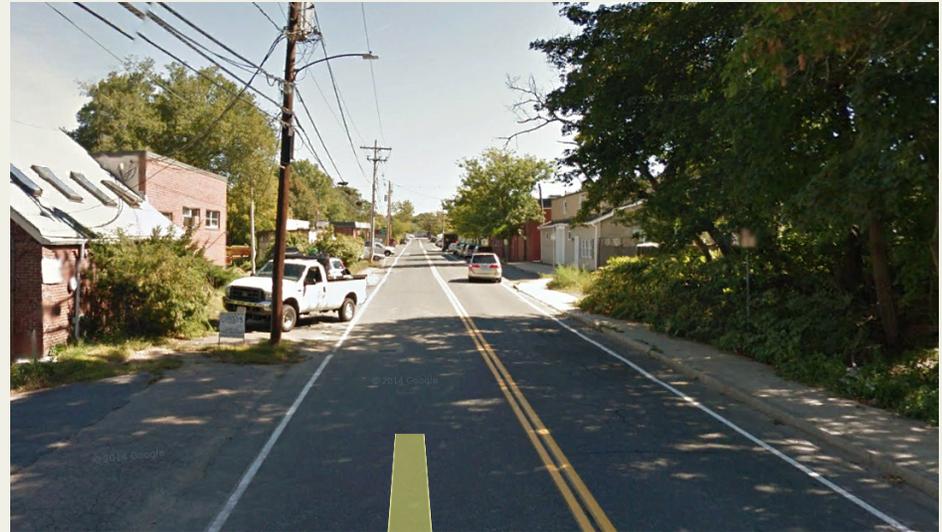
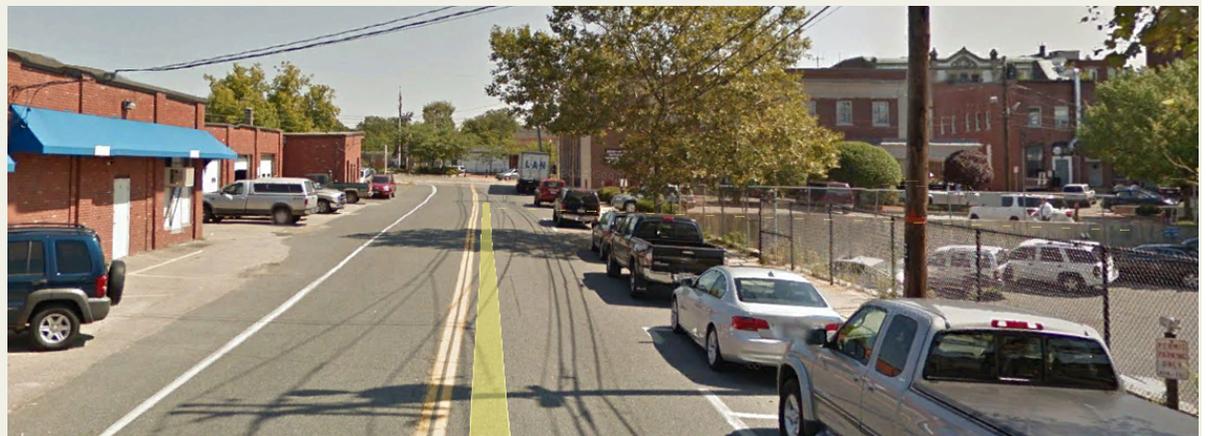
Middlesex Avenue

- No sidewalk on north side – wide uneven driveways but many businesses
- No bike accommodations
- No buffer zone between sidewalk and road on south side
- Tree root tripping hazards

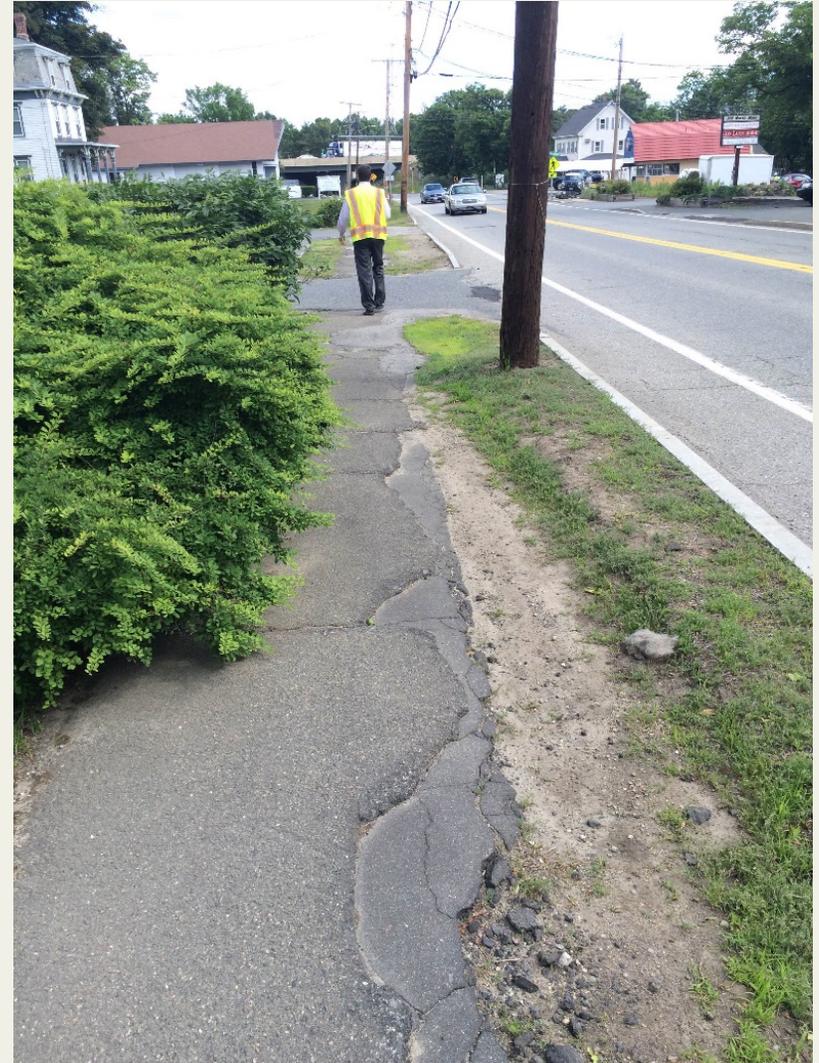
North Main Street/Route 27

- Sidewalk on west side in very poor condition
- Narrow with tripping hazards and overgrown vegetation
- No bike accommodations

Note: North Main Street improvements currently under design

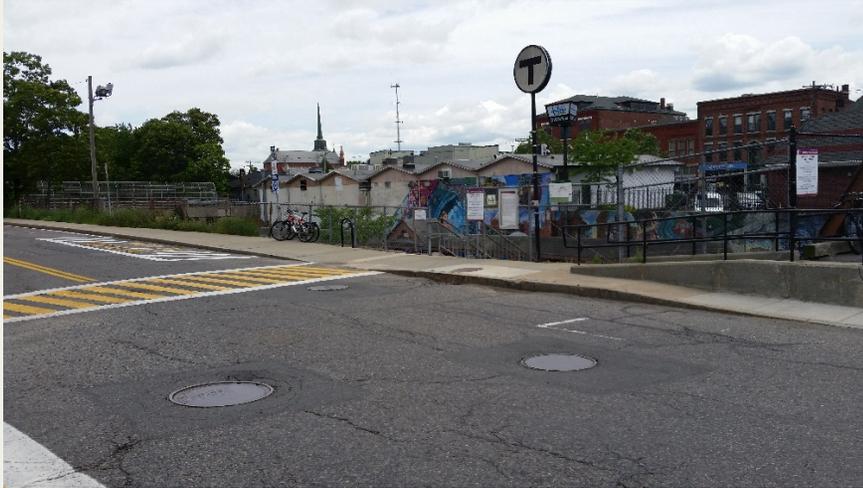
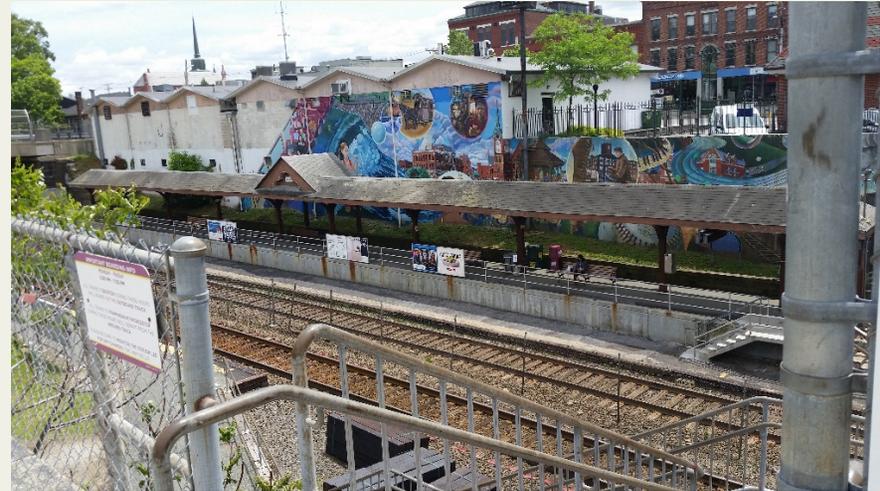
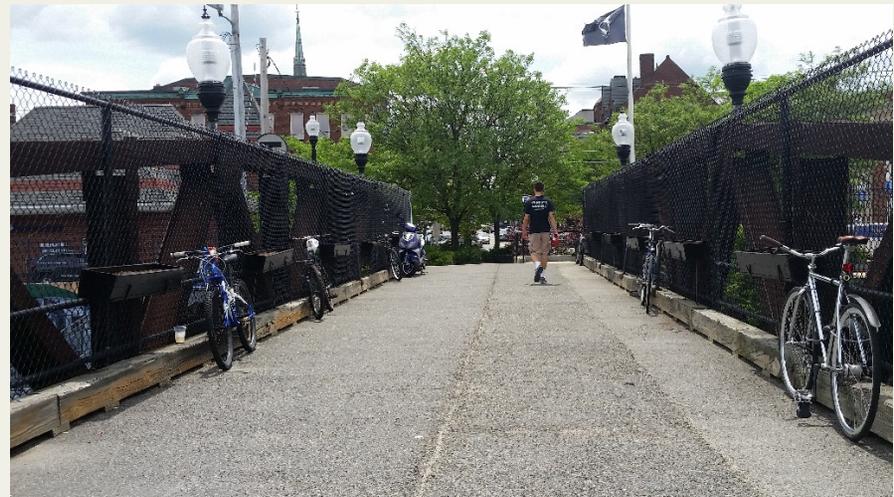
Roadway Windshield Survey: Natick Center MBTA Station

**No ramps or elevators despite
difference in grade – does not meet ADA**

Bike Storage insufficient

**No bike lane and drop-off area produces
conflict**

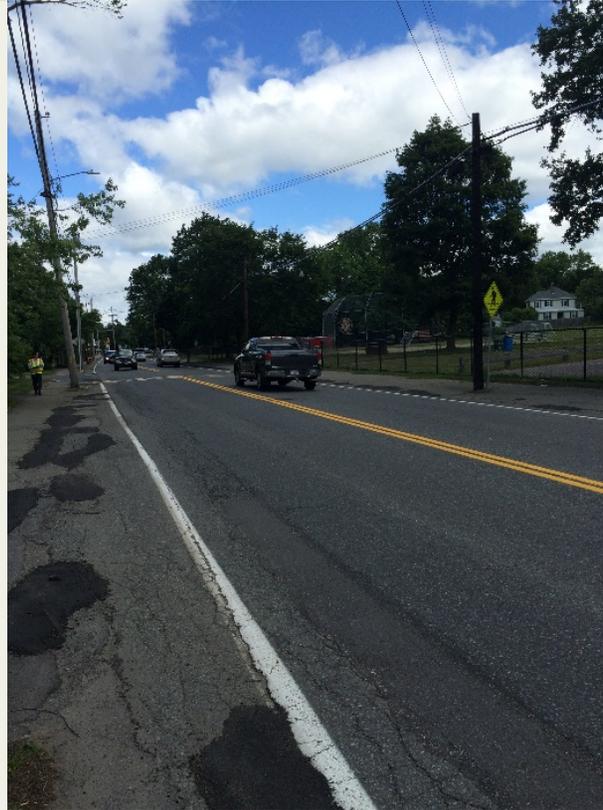
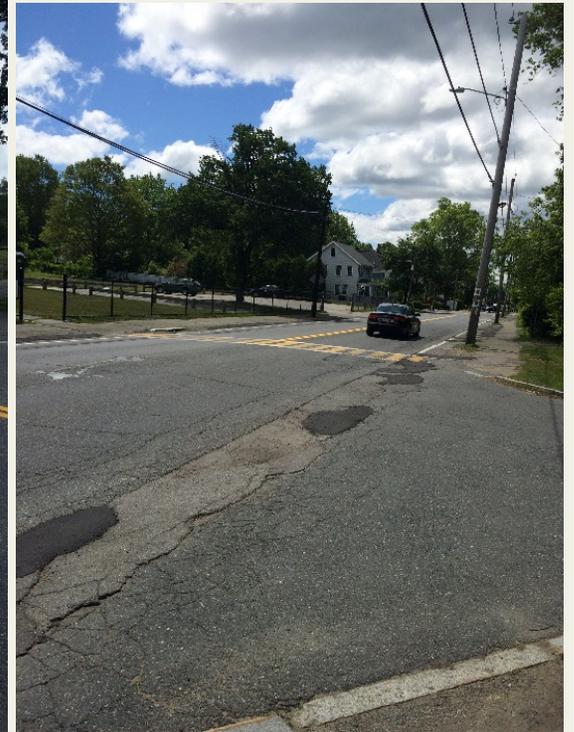
North Main Street (Route 27) at Neil Circle

- Pedestrian warning signs are non-standard and NB sign is bent away from roadway
- Curb ramp is rutted asphalt with no detectable warning panels
- Crosswalk markings are faded

Note: North Main Street improvements currently under design

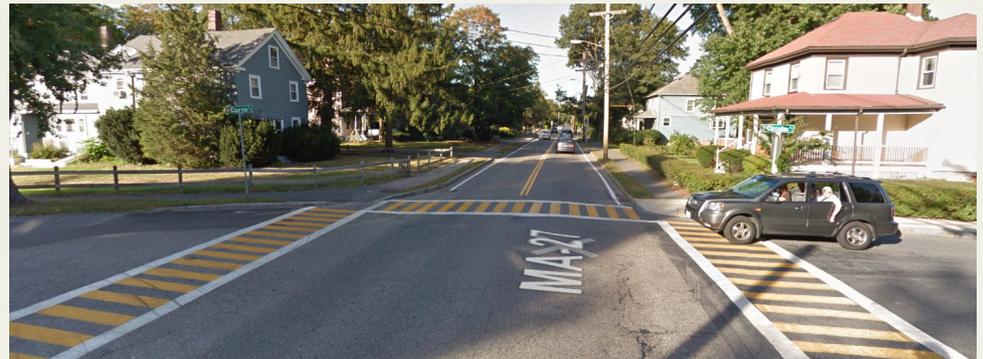
Looking north on Route 27

- Heavy vehicular traffic, drivers often block crosswalks due to restricted sight triangle and must focus more on conflicting vehicles and constrained geometry
- Only the east crosswalk includes detectable warning panels
- Bike crash occurred at this intersection

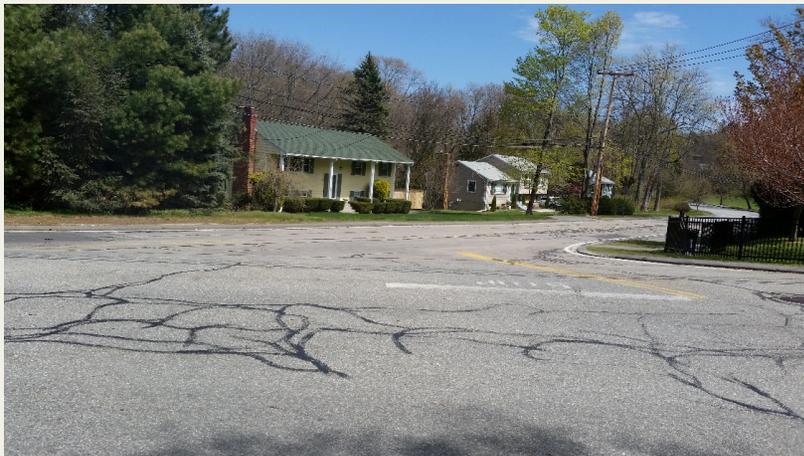
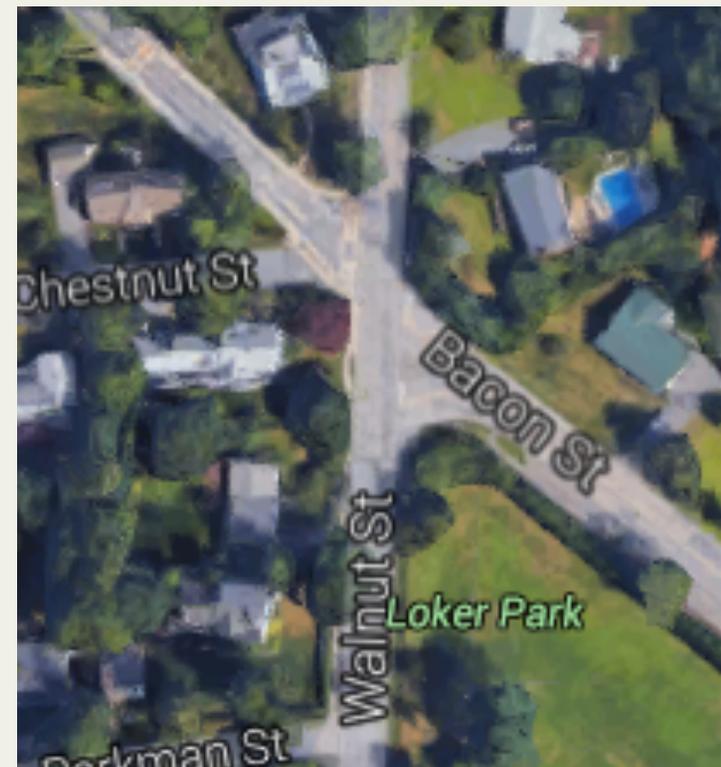
Walnut Street/Bacon Street/Chestnut Street

- WB Bacon Street to SB Walnut Street left turns are directed into the inside corner (see aerial)
- No crosswalk provided on east side of intersection

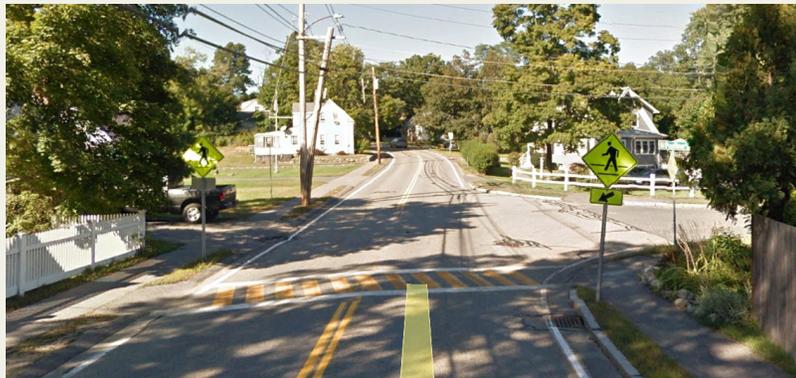
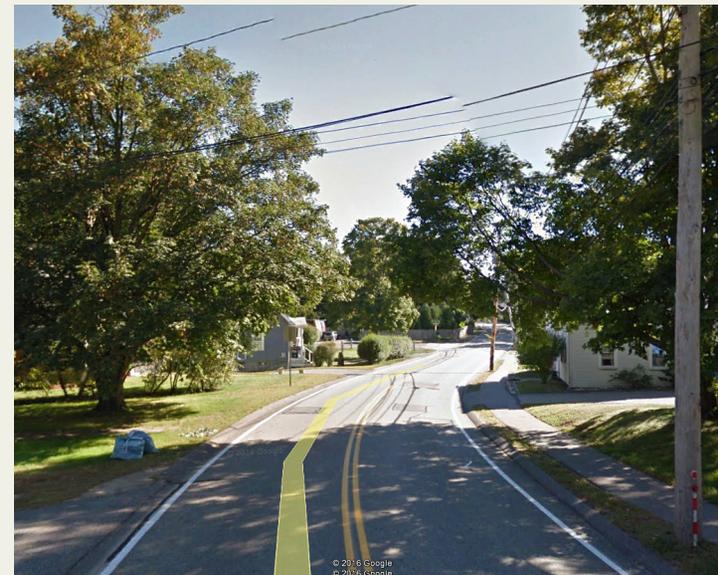
Marion Street/Pauline Drive

- Rutted asphalt on curb ramp, no detectable warning panels
- Old-style pedestrian warning signage
- Curvature reduces sight distance

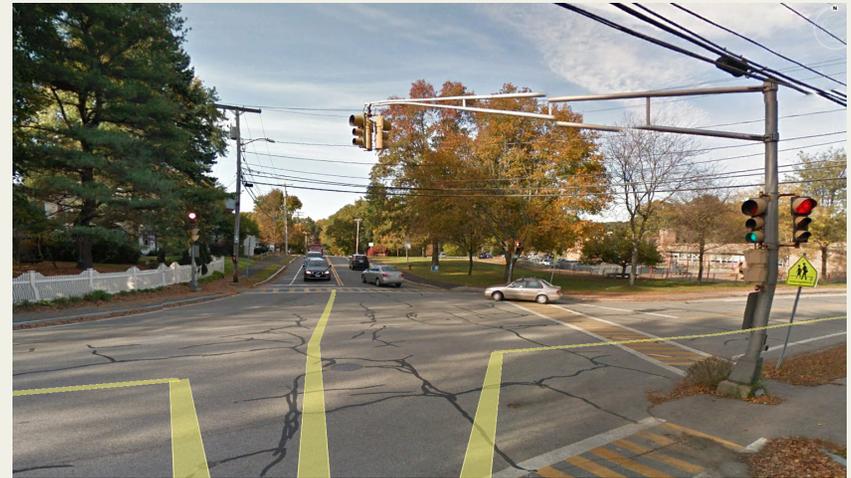
Looking north on Arbor Circle

- Curb ramps do not have detectable warning panels and are not aligned with crosswalks
- There is no school speed limit on the Bacon Street approaches, but a crest vertical curve, a 60' wide 2-lane cross section (encouraging high speeds), and outdated 8" signal heads restrict drivers' visibility of pedestrians crossing
- The walk indication is text and not the standard man symbol
- The pedestrian timing for the exclusive phase does not meet MUTCD standards – 6 seconds "walk" and 9 seconds FDW are provided for a 60' crossing across Bacon Street (40' across Oak Street)
- No countdown timers are provided with the pedestrian signals

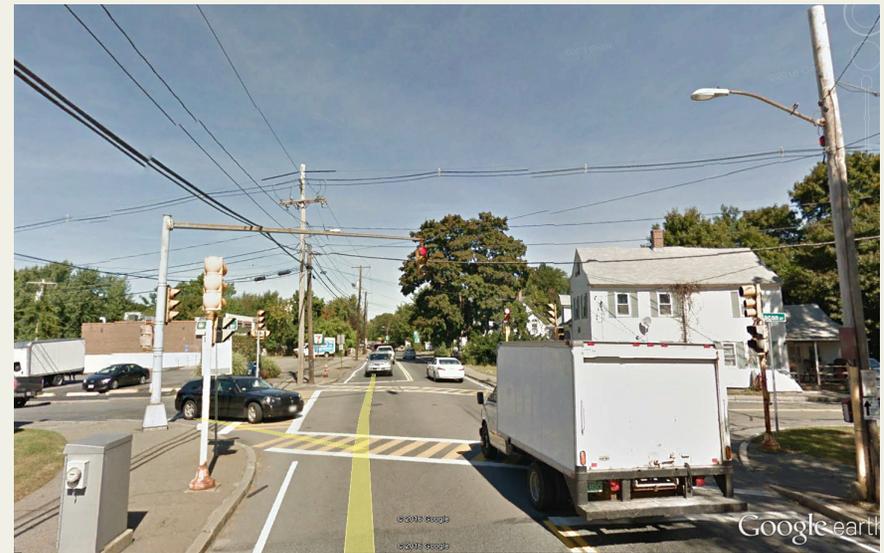
North Main Street (Route 27) / Bacon Street

Pedestrian signal indications inconsistent - text or standard symbols, and some are bent or dark
Pedestrian signals do not have countdown timers
No bicycle lanes or detection
No sidewalk
Crosswalk markings faded
Vehicle congestion due to heavy left-turn volumes with no left turn lanes or protected phases results in blocked crosswalks

Note: North Main Street improvements currently under design

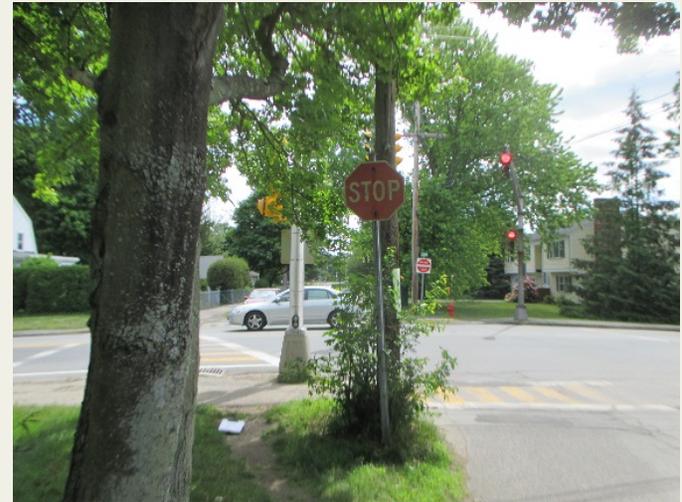
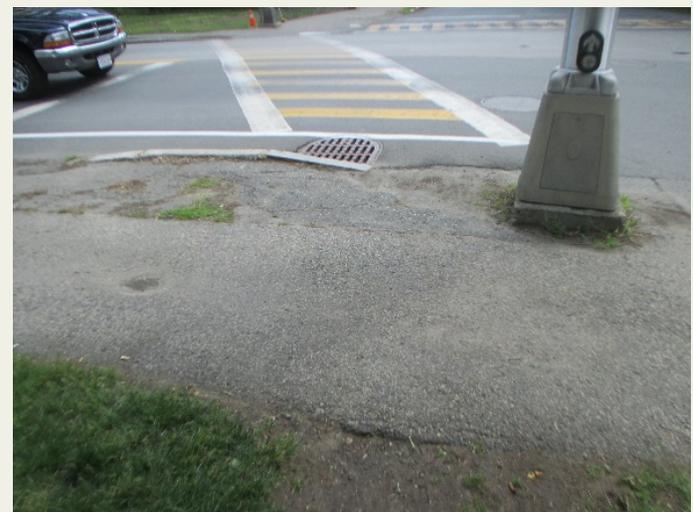
North Main Street (Route 27) / East Evergreen Road

Pedestrian signal timing insufficient
Antiquated equipment (text "walk" on NE corner)
Crosswalk only marked across north leg
No push buttons on SE or SW corner
NW curb ramp uneven and blocked by signal pole
No bike facilities
Marked Crosswalk at an angle – longer than needed
No countdown timers
Conflicting STOP sign on signalized EB approach

Note: North Main Street improvements currently under design

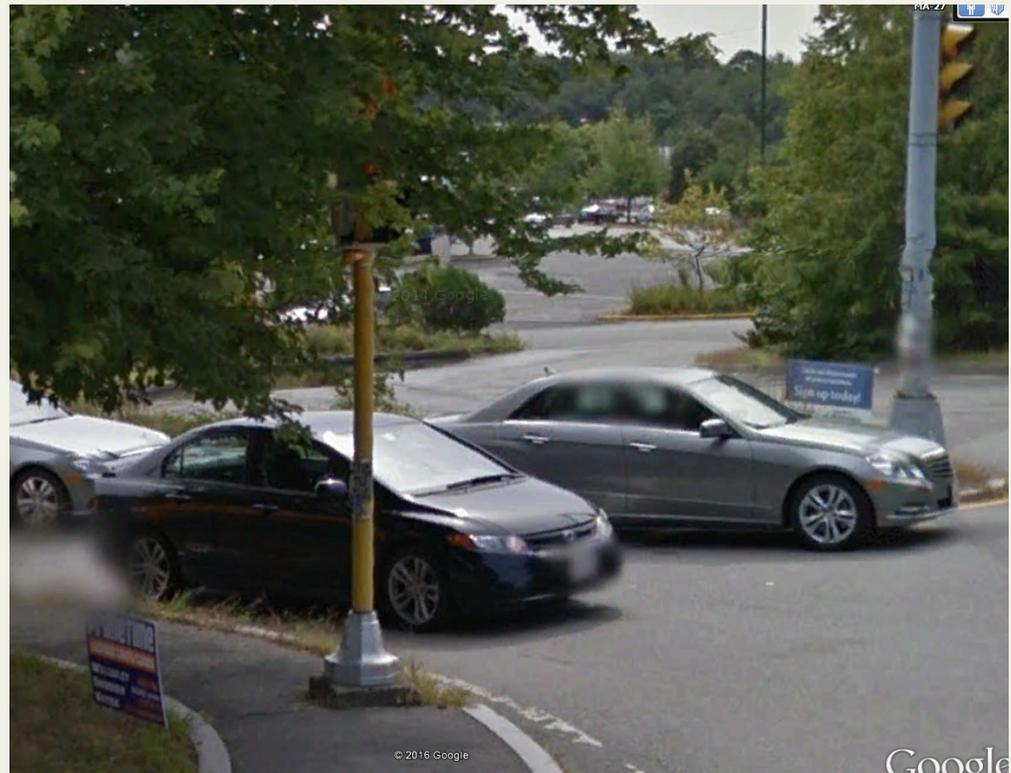
North Main Street (Route 27) / Shopping Center North of Route 9

Faded pavement markings

“WALK” text indication on NE corner
and man symbol on NW corner both dark

Pushbutton on NE corner not ADA-compliant

No countdown timers

Note: North Main Street improvements currently under design

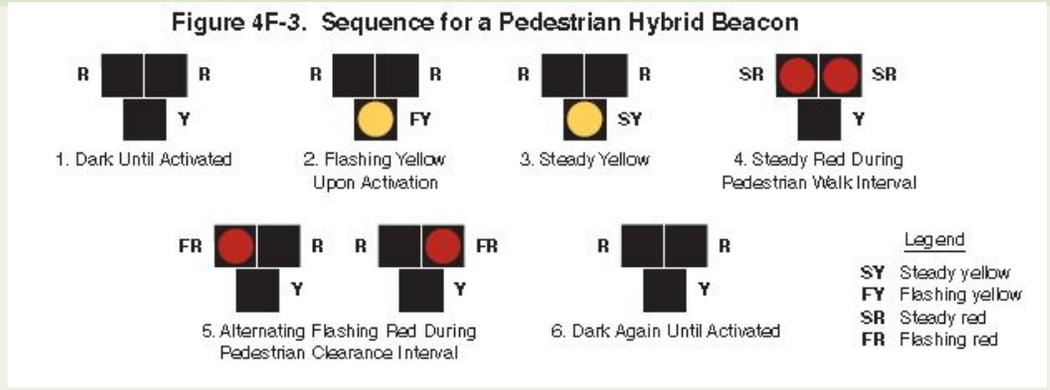
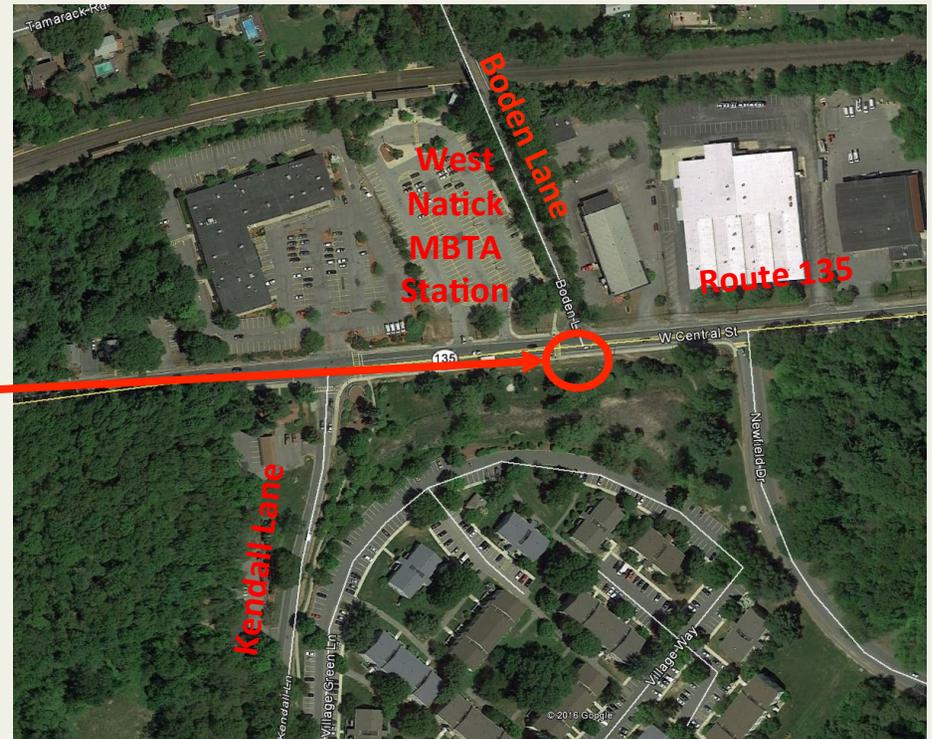
West Natick MBTA Station

It is difficult for pedestrians to cross Route 135 at Boden Lane to access residences on the south side without signal control

Potential Pedestrian Hybrid Beacon (PHB)

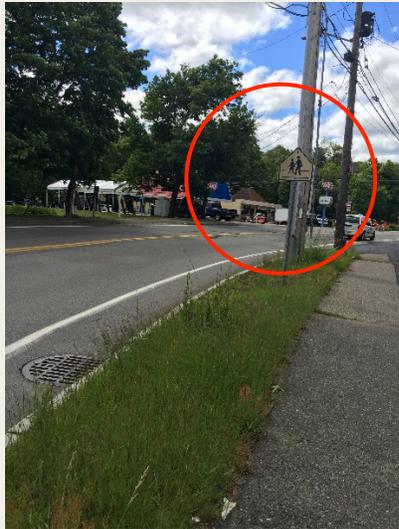
Route 27 southbound, just south of MassPike overpass

Examples of Non-Compliant Pedestrian Warning Signs in Natick

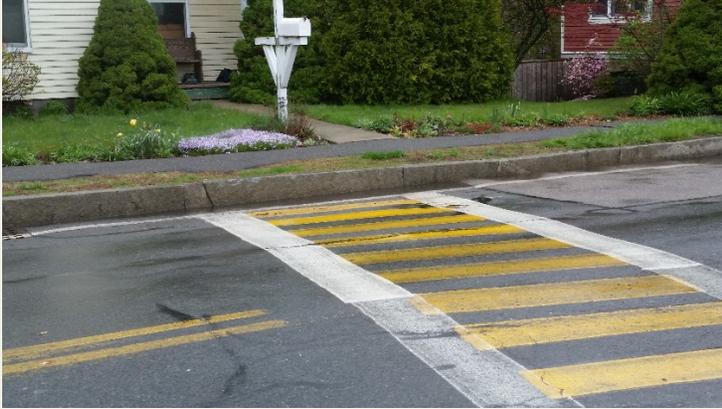
Pond Street at Oakland Street

Examples of Lack of Detectable Warning Panels or Curb Ramps in Natick

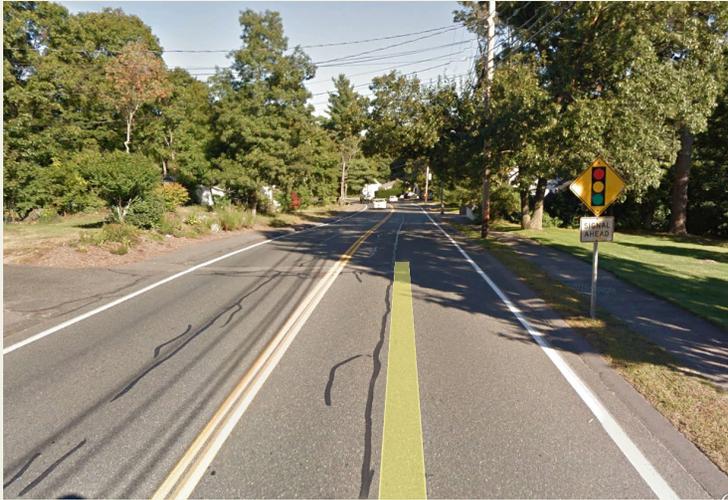
North side of Bacon Street near Lilja Elementary School

Examples of Missing Sidewalk Connections in Natick within School/MBTA/MWRTA Buffer Zones

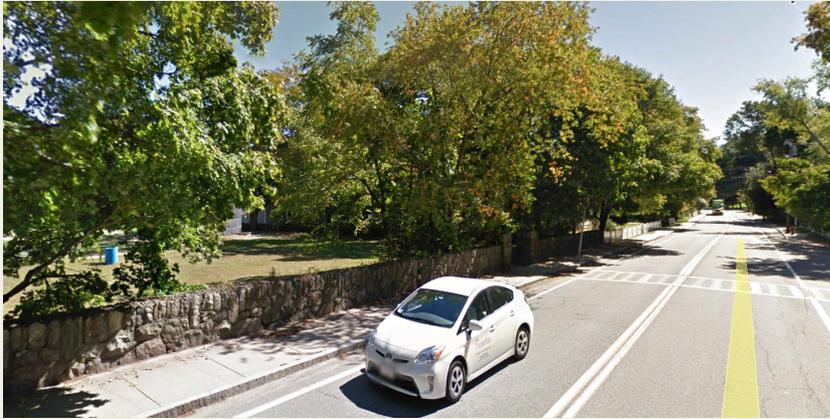
Pleasant Street South Fields

Locations in Need of Bike Storage in Natick
