# Sassamon Trace Golf Course

## Town of Natick ADA Transition Plan

August 2023

Institute for Human Centered Design

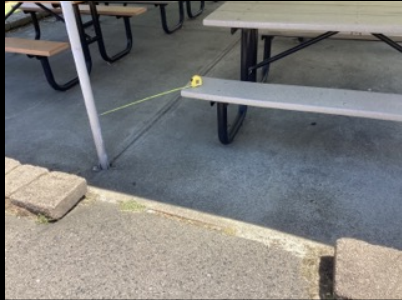
| ID | Location | Floor | Room | Element | Type | Photo | Issues | Current Measure | Recommendations | Quantity | Price | Cost Estimation |
|--|---|---|---|---|---|--|---|---|---|---|---|---|
| 1 | Picnic Pavilion | Ext. | | Exterior Access Route | Exterior | | Exterior route < 36" wide | 20" | Ensure that a clear width of 36" min. is maintained at the accessible route. Relocate tables. | 1 | Labor | Labor |

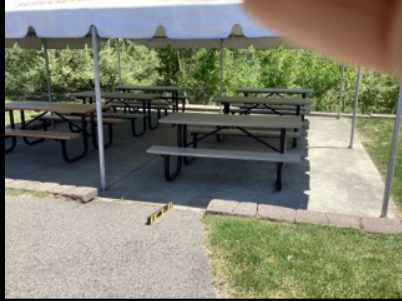
| ID | Location | Floor | Room | Element | Type | Photo | Issues | Current Measure | Recommendations | Quantity | Price | Cost Estimation |
|--|---|---|---|---|---|--|---|---|---|---|---|---|
| 2 | Picnic Pavilion | Ext. | | Exterior Access Route | Exterior | | Running slope > 1:20 (5.00%) | 16% | Reduce the running slope to be no steeper than 1:20 (5.00%). | 1 | - | - |

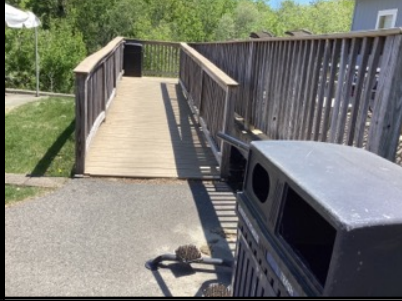
| ID | Location | Floor | Room | Element | Type | Photo | Issues | Current Measure | Recommendations | Quantity | Price | Cost Estimation |
|--|---|---|---|---|---|--|---|---|---|---|---|---|
| 3 | Ramp to Clubhouse | Ext. | | Exterior Access Route | Exterior | | Level changes > 1/4" | 2" | Alter the change in level to be 1/4" high max. | 1 | Labor | Labor |

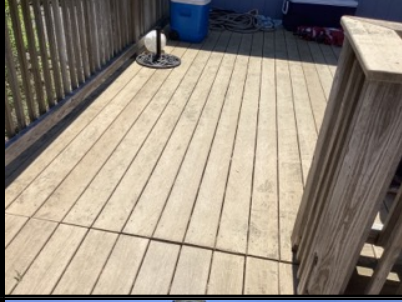
| ID | Location | Floor | Room | Element | Type | Photo | Issues | Current Measure | Recommendations | Quantity | Price | Cost Estimation |
|--|---|---|---|---|---|--|---|---|---|---|---|---|
| 4 | Ramp to Clubhouse | Ext. | | Exterior Access Route | Exterior | | Level changes > 1/4" | .5" | Alter the change in level to be 1/4" high max. | 1 | Labor | Labor |

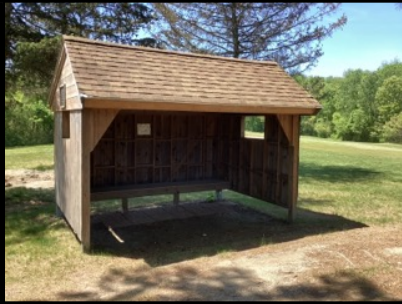
| ID | Location | Floor | Room | Element | Type | Photo | Issues | Current Measure | Recommendations | Quantity | Price | Cost Estimation |
|---|---|---|---|---|---|--|--|---|--|---|---|---|
| 6 | Shelter | 1 | | Exterior Access Route | Exterior | | Vertical clearance < 80" above ground | 68" | Shelter will need to be rebuilt to provide vertical clearance. For now, consider adding signage that says, "Low Headroom" or, "Low Ceiling". | 1 | 450 | \$450 |

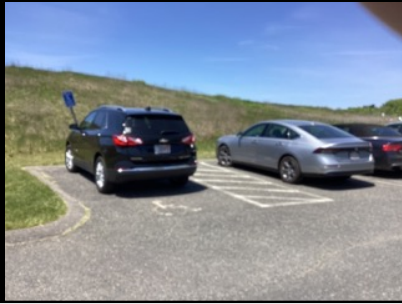
| ID | Location | Floor | Room | Element | Type | Photo | Issues | Current Measure | Recommendations | Quantity | Price | Cost Estimation |
|---|---|---|---|---|---|--|--|---|--|---|---|---|
| 7 | Parking | Ext. | | Off-Street Parking Lot or Garage | Visitor | | Total # of parking<br>Total # of designated car accessible parking spaces<br>Total # of designated van accessible spaces | 45<br>1<br>0 | Provide a van accessible parking space in the parking lot. | 1 | 2405 | \$2405 |

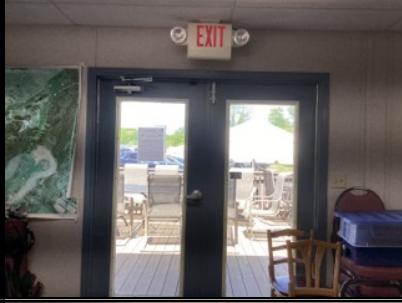
| ID | Location | Floor | Room | Element | Type | Photo | Issues | Current Measure | Recommendations | Quantity | Price | Cost Estimation |
|---|---|---|---|---|---|--|--|---|--|---|---|---|
| 8 | Clubhouse - Main Egress | Ext. | | Means of Egress | N/A | | Tactile exit sign not provided<br>Illuminated ISA symbol not provided (MAAB) | -<br>- | Ensure that a tactile exit sign with raised characters and braille is provided at the exit door. Mount the sign between 48" - 60" above the finished floor located on the right side of the double doors.<br>When the illuminated exit sign is repaired or replaced, provide an illuminated sign with the International Symbol of Accessibility (ISA). | 1 | 302<br>- | \$302 |

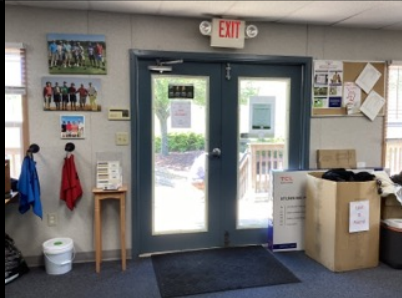
| ID | Location | Floor | Room | Element | Type | Photo | Issues | Current Measure | Recommendations | Quantity | Price | Cost Estimation |
|---|---|---|---|---|---|--|--|---|--|---|---|---|
| 9 | Clubhouse Second Egress to Deck | Ext. | | Means of Egress | N/A | | Tactile exit sign not provided<br>Illuminated ISA symbol not provided (MAAB) | -<br>- | Ensure that a tactile exit sign with raised characters and braille is provided at the exit door. Mount the sign between 48" - 60" above the finished floor located on the right side of the double doors.<br>When the illuminated exit sign is repaired or replaced, provide an illuminated sign with the International Symbol of Accessibility (ISA). | 1 | 302<br>- | \$302 |

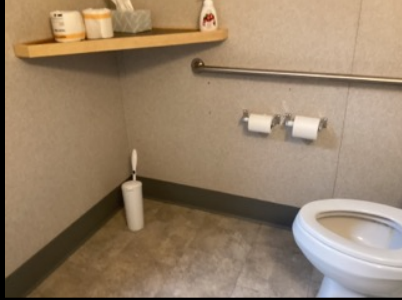
| ID | Location | Floor | Room | Element | Type | Photo | Issues | Current Measure | Recommendations | Quantity | Price | Cost Estimation |
|---|--|---|---|---|---|--|---|---|---|---|---|---|
| 10 | Women's Single-User Toilet Room | 1 | | Interior Access Route | Interior | | Obstructed by protruding objects | 15" | Relocate shelf. It acts as a protruding object and is located in the clear floor space required at the toilet. | 1 | Labor | Labor |

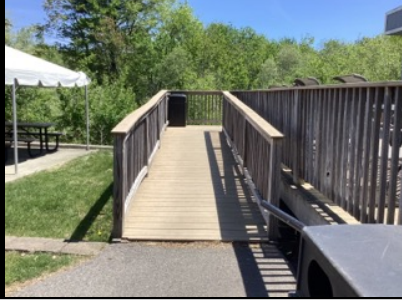
| ID | Location | Floor | Room | Element | Type | Photo | Issues | Current Measure | Recommendations | Quantity | Price | Cost Estimation |
|---|--|---|---|---|---|--|---|---|---|---|---|---|
| 11 | Ramp to Clubhouse | Ext. | | Ramps | Exterior | | Handrails < 34" or > 38" above ramp surface<br>Lower handrails < 18" or > 20" above ramp surface (MAAB)<br>Handrails do not extend 12" past top & bottom<br>Handrails have noncompliant cross section | -<br>-<br>-<br>- | Provide handrails with 1-1/4" to 1-1/2" circular cross section. Locate one set of handrails 34"-38" high above the ramp surface and another set 18"-20" high above the ramp surface.<br>Ensure that handrails to extend horizontally above the landing for 12" min. beyond the top and bottom of ramp runs. | 4 | 1716 | \$6864 |

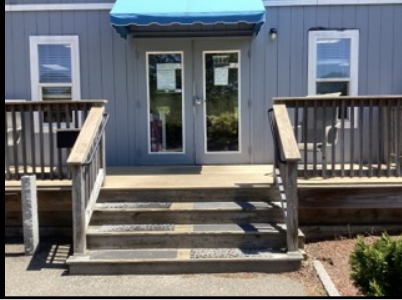
| ID | Location | Floor | Room | Element | Type | Photo | Issues | Current Measure | Recommendations | Quantity | Price | Cost Estimation |
|---|--|---|---|---|---|--|---|---|---|---|---|---|
| 12 | Steps to Clubhouse | Ext. | | Stairways | Exterior | | Handrail height < 34" or > 38"<br>Handrails do not extend 12" from stairs<br>Handrails have noncompliant cross section | 27.5"<br>-<br>- | Provide handrails with a 1 1/4" - 2" circular cross section that are 34"-38" high above the stair.<br>Top: Ensure handrails extend horizontally above the landing for 12" min. beginning above the first riser nosing.<br>Bottom: Ensure that the sloped bottom extension extends 12" plus the width of one tread beyond last riser nosing in same direction as stair flight. | 2 | 1716 | \$3432 |

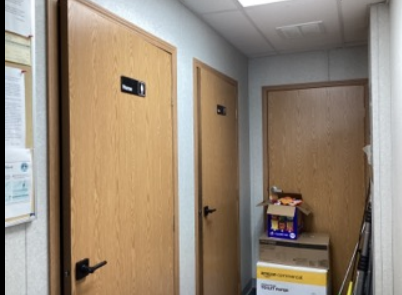
| ID | Location | Floor | Room | Element | Type | Photo | Issues | Current Measure | Recommendations | Quantity | Price | Cost Estimation |
|---|--|---|---|---|---|--|---|---|---|---|---|---|
| 13 | Men's and Women's Single-User Toilet Rooms | 1 | | Signage | Designation | | Raised characters not provided<br>Braille not provided<br>Sign not located on the latch side of the door | -<br>-<br>- | Provide text with raised characters duplicated in braille.<br>Locate signs at permanent rooms alongside the door on the latch side. | 2 | 302 | \$604 |

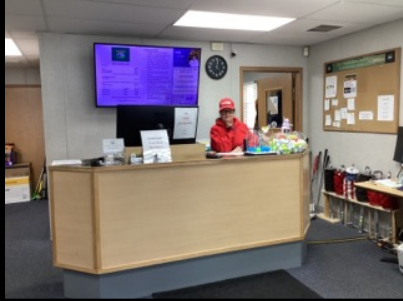
| ID | Location | Floor | Room | Element | Type | Photo | Issues | Current Measure | Recommendations | Quantity | Price | Cost Estimation |
|---|---|---|---|---|---|--|--|---|---|---|---|---|
| 14 | Clubhouse | 1 | | Service Counter | N/A | | Counter > 36" high | 37" | Provide a counter that is 36" max. above the ground. | 1 | 1144 | \$1144 |

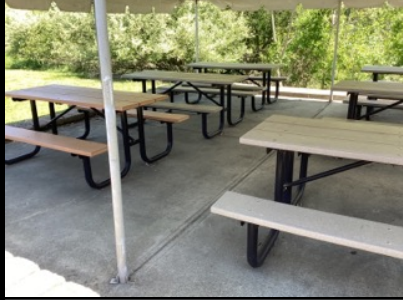
| ID | Location | Floor | Room | Element | Type | Photo | Issues | Current Measure | Recommendations | Quantity | Price | Cost Estimation |
|---|---|---|---|---|---|--|--|---|---|---|---|---|
| 15 | Picnic Pavilion | Ext. | | Picnic Tables | N/A | | Number of seating spaces at picnic tables<br>At least 5% accessible spaces not provided<br>Knee clearance less than 19" deep | 6<br>-<br>- | Ensure that at least 5% (minimum one) of picnic tables are accessible.<br>Provide at least one picnic table with knee clearance that is 19" deep min. | 1 | 1400 | \$1400 |

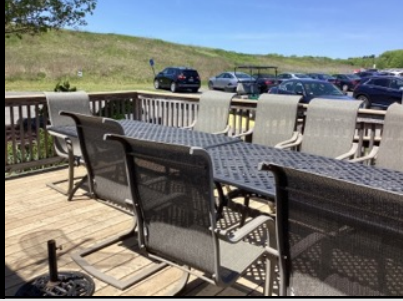
| ID | Location | Floor | Room | Element | Type | Photo | Issues | Current Measure | Recommendations | Quantity | Price | Cost Estimation |
|---|---|---|---|---|---|--|--|---|---|---|---|---|
| 16 | Clubhouse Deck Table | Ext. | | Picnic Tables | N/A | | Toe or knee clearance at tables not provided | 23" | Provide at least 1 picnic table (or ensure that 5% of picnic tables) have toe and knee clearance. Knee clearance should be 27" min. high. | 1 | 1500 | \$1500 |

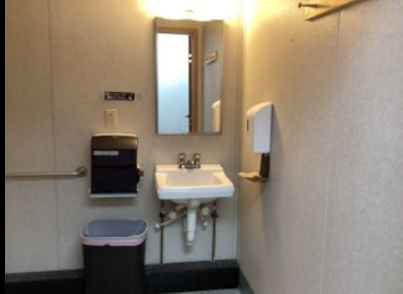
| ID | Location | Floor | Room | Element | Type | Photo | Issues | Current Measure | Recommendations | Quantity | Price | Cost Estimation |
|---|---|---|---|---|---|--|--|---|---|---|---|---|
| 17 | Women's Single-User Toilet Room | 1 | | Lavatory | N/A | | Toe or knee clearances not provided | 22.5" | Provide at least one lavatory with knee and toe clearance positioned for a forward approach. | 1 | 2192 | \$2192 |

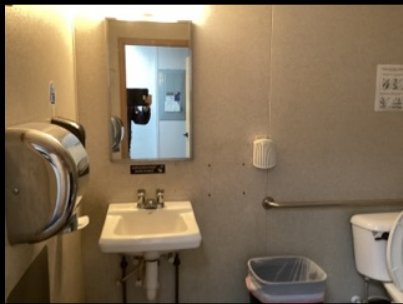
| ID | Location | Floor | Room | Element | Type | Photo | Issues | Current Measure | Recommendations | Quantity | Price | Cost Estimation |
|---|---|---|---|---|---|--|--|---|--|---|---|---|
| 18 | Men's Single-User Toilet Room | 1 | | Lavatory | N/A | | Toe or knee clearances not provided | 22" | Provide at least one lavatory with knee and toe clearance positioned for a forward approach. | 1 | 2192 | \$2192 |

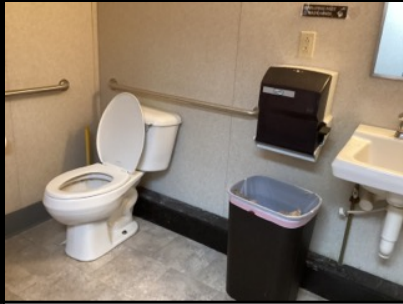
| ID | Location | Floor | Room | Element | Type | Photo | Issues | Current Measure | Recommendations | Quantity | Price | Cost Estimation |
|---|---|---|---|---|---|--|--|---|--|---|---|---|
| 19 | Women's Single-User Toilet Room | 1 | | Single-User Toilet | N/A | | Toilet seat < 17" or > 19" high<br>Centerline < or > 18" (MAAB)<br>Side grab bar < 54" from back wall<br>Side or rear grab bar < 33" or > 36" high<br>Clearance at toilet < 72" clear depth (MAAB) | 13"<br>13"<br>48"<br>31"<br>65.5" | Install a toilet with a seat between 17"- 19" high above the finished floor. Relocate toilet so that the centerline is 18" from the side wall. Provide a side wall grab bar that is 42" long min. located 12" max. from the rear wall.<br>Mount grab bars 33"- 36" above the finished floor. Clearance at toilet compartment complies with the ADA but not 521 CMR. It is not compliant but is usable. | 1 | 2816<br>3676<br>459<br>459 | \$7410 |

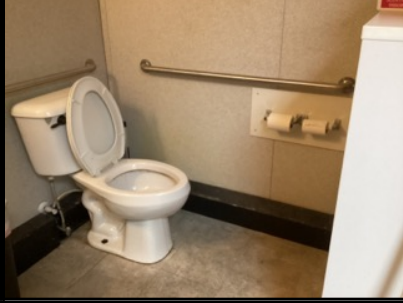
| ID | Location | Floor | Room | Element | Type | Photo | Issues | Current Measure | Recommendations | Quantity | Price | Cost Estimation |
|---|---|---|---|---|---|--|--|---|--|---|---|---|
| 20 | Men's Single-User Toilet Room | 1 | | Single-User Toilet | N/A | | Toilet seat < 17" or > 19" high<br>Centerline < or > 18" (MAAB)<br>Side grab bar < 54" from back wall<br>Side or rear grab bar < 33" or > 36" high<br>< 42" provided in front of toilet | 13"<br>13"<br>49"<br>30.5"<br>22" | Install a toilet with a seat between 17"- 19" high above the finished floor. Relocate toilet so that the centerline is 18" from the side wall. Provide a side wall grab bar that is 42" long min. located 12" max. from the rear wall. Mount grab bars 33"- 36" above the finished floor. Relocate cabinet to ensure that there is 42" min. located in front of the toilet. | 1 | 2816<br>3676<br>459<br>459 | \$7410 |

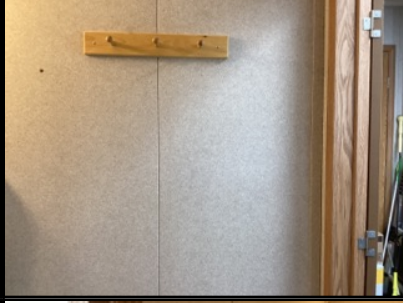
| ID | Location | Floor | Room | Element | Type | Photo | Issues | Current Measure | Recommendations | Quantity | Price | Cost Estimation |
|---|---|---|---|---|---|--|--|---|--|---|---|---|
| 21 | Women's Single-User Toilet Room | 1 | | Single-User Toilet | N/A | | Hook located > 54" high | 63.5" | Locate the coat hook no higher than 48" above the finished floor. | 1 | 150 | \$150 |

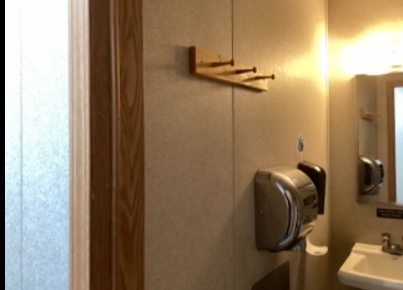
| ID | Location | Floor | Room | Element | Type | Photo | Issues | Current Measure | Recommendations | Quantity | Price | Cost Estimation |
|---|---|---|---|---|---|--|--|---|--|---|---|---|
| 22 | Men's Single-User Toilet Room | 1 | | Single-User Toilet | N/A | | Hook located > 54" high | 64" | Locate the coat hook no higher than 48" above the finished floor. | 1 | 150 | \$150 |

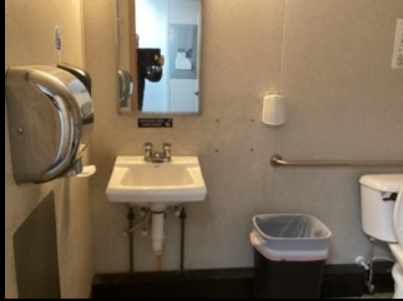
| ID | Location | Floor | Room | Element | Type | Photo | Issues | Current Measure | Recommendations | Quantity | Price | Cost Estimation |
|---|---|---|---|---|---|--|--|---|--|---|---|---|
| 23 | Men's Single-User Toilet Room | 1 | | Dispensers | Hand Dryer | | Dispenser acts as a protruding object | 6" | Relocate hand dryer out of the circulation path. Consider providing an accessible low profile hand dryer. (Cost estimate for a low profile hand dryer that is less than 4" wide.) | 1 | 949 | \$949 |

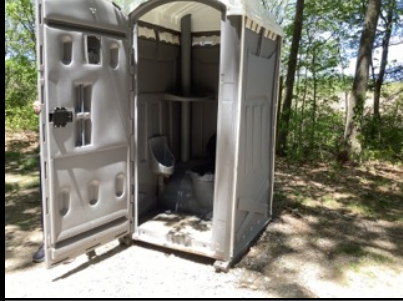
| ID | Location | Floor | Room | Element | Type | Photo | Issues | Current Measure | Recommendations | Quantity | Price | Cost Estimation |
|---|---|---|---|---|---|--|--|---|--|---|---|---|
| 24 | Near Hole 9 | 1 | | Portable Toilet | N/A | | Not located on an accessible route<br>Accessible portable toilets not provided | 8"<br>- | Locate an accessible portable toilet on an accessible route. Ensure that at least 5% of portable toilets (with a minimum of one) are accessible. (Cost is for the accessible portable toilet.) | 1 | -<br>4600 | \$4600 |

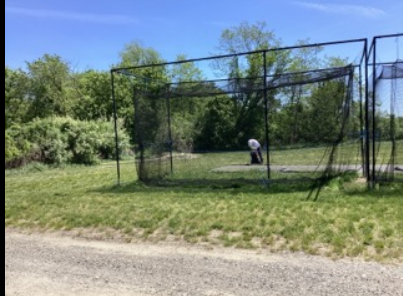
| ID | Location | Floor | Room | Element | Type | Photo | Issues | Current Measure | Recommendations | Quantity | Price | Cost Estimation |
|---|---|---|---|---|---|--|--|---|--|---|---|---|
| 25 | Driving Range | 1 | | Exterior Route | | | | | Recommend providing a 48" wide stone dust route to the driving range. | 1 | - | - |
